ALMEDA SIMS WWTP AND SLUDGE

PROCESSING FACILITY IMPROVEMENTS

Asbestos and Lead Survey Report

Almeda Sims WWTP and Sludge Processing Facility 12319 ½ Almeda Road HOUSTON, TEXAS

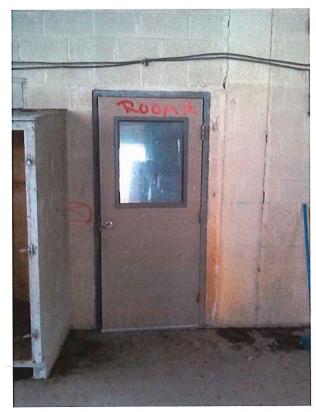
2nd level Belt Press area

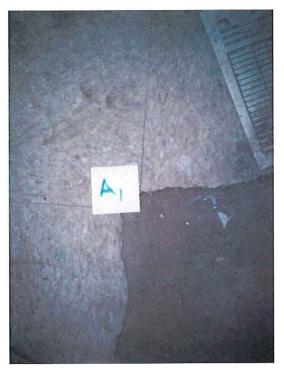
Flooring 2nd level Belt Press area

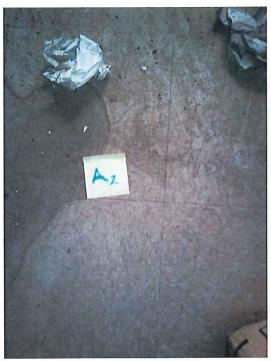
Flooring 2nd level Belt Press area

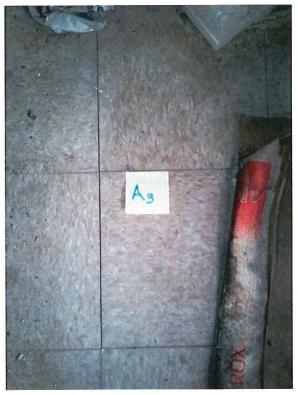
Flooring 2nd level Belt Press area

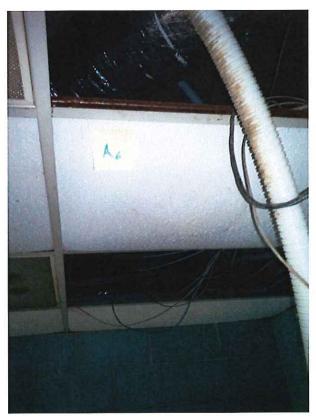
2 x 4 ceiling panels 2nd level Belt Press area

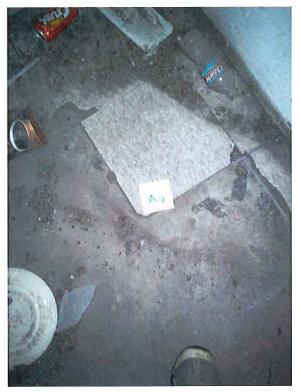
Flooring 2nd level Belt Press area

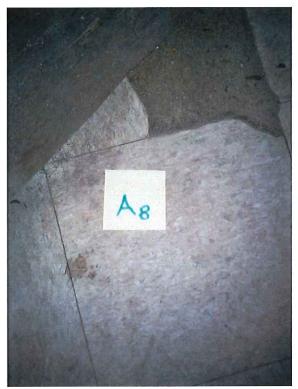
Flooring 2nd level Belt Press area

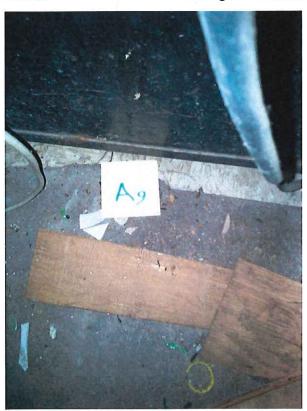
Flooring 2nd level Belt Press area

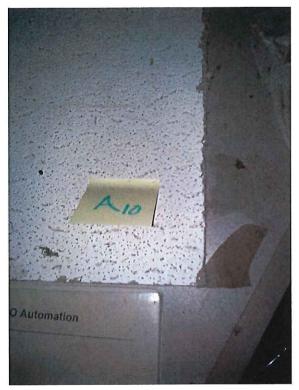
2 x 4 ceiling panels 2nd level Belt Press area

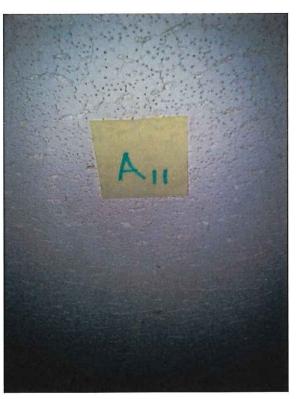
2 x 4 ceiling panels 2nd level Belt Press area

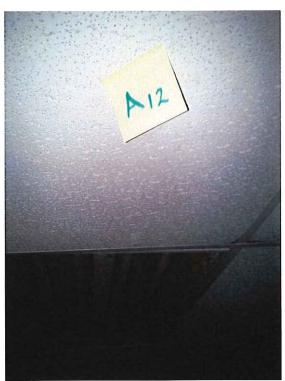
2 x 4 ceiling panels 2nd level Belt Press area

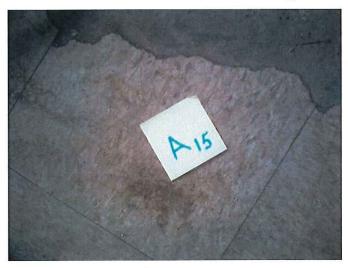
Flooring 2nd level Belt Press area

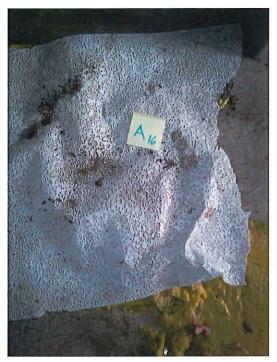
2 x 4 ceiling panels 2nd level Belt Press area

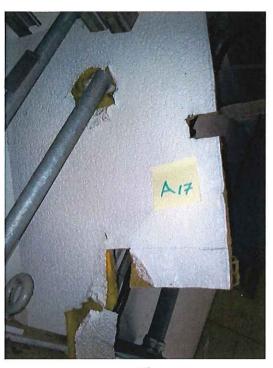
2 x 4 ceiling panels 2nd level Belt Press area

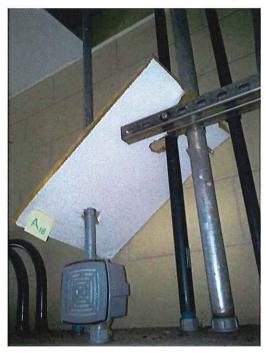
2 x 4 ceiling panels 2nd level Belt Press area

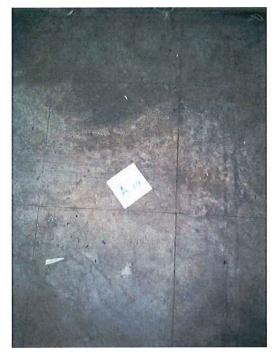
Flooring 2nd level Belt Press area

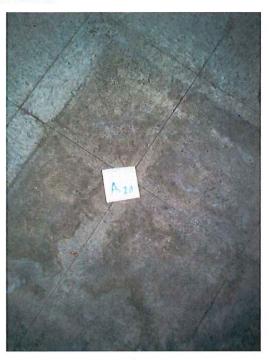
Flooring 2nd level Belt Press area

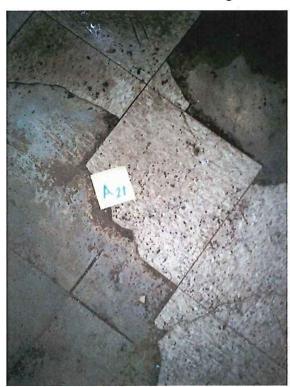
Flooring 2nd level Belt Press area

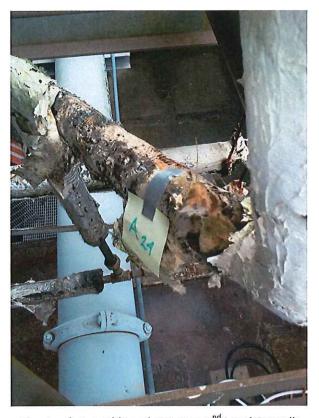
Pipe Insulation Old Load Out Area 2nd Level Catwalk

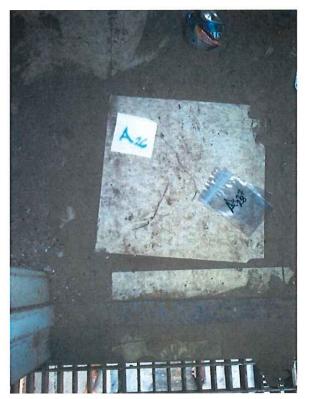
Flooring 2nd level Old Load Out area

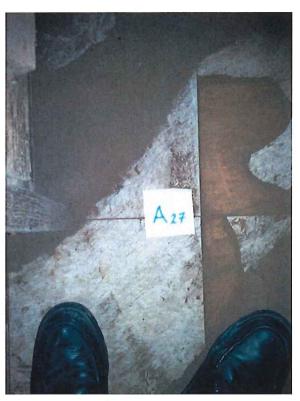
Flooring 2nd level Old Load Out area

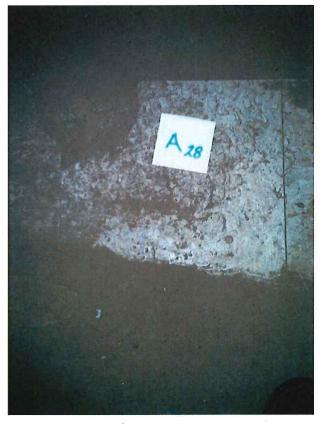
Flooring 2nd level Old Load Out area

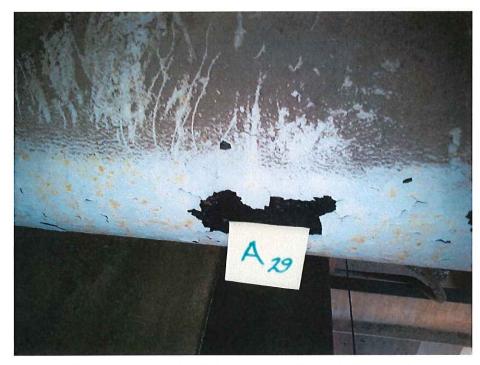
Pipe coating overhead pipe at area adjacent to Furnace B

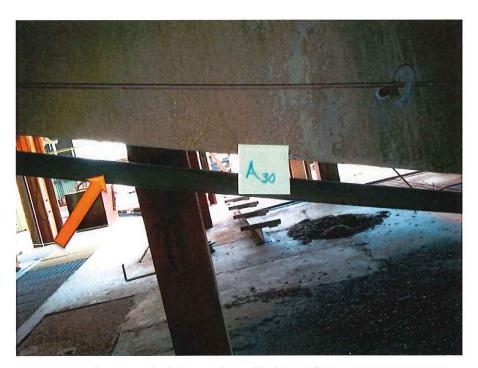
Conveyor belt Ground Level below Belt Press area

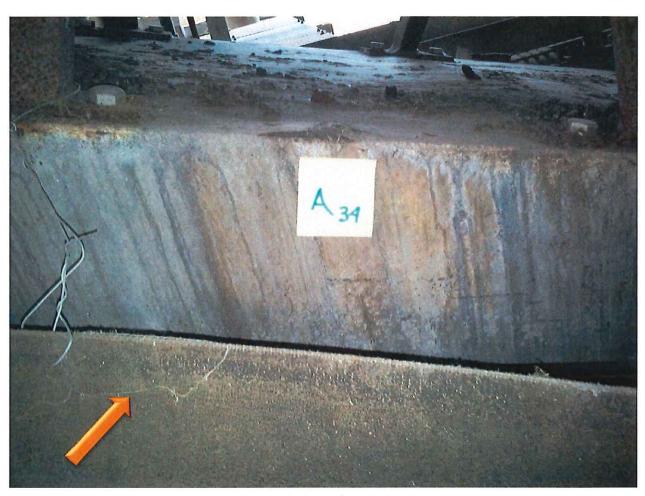
Conveyor Belt 2nd level above Furnace B

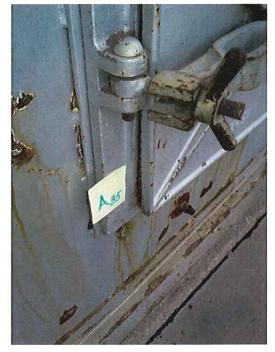
North area at man way entrance ground level

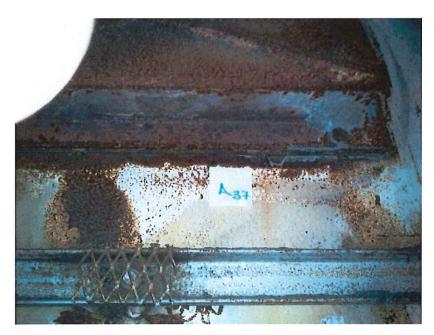
East area at man way entrance ground level

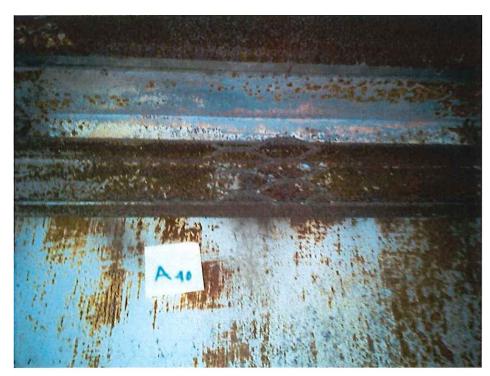
East area at man way entrance ground level

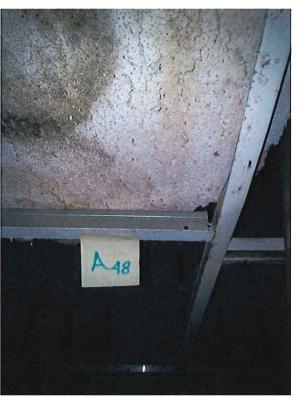
Ceiling Panels in control room area

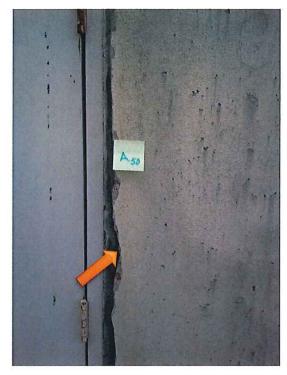
Silo A Exterior Grout Material

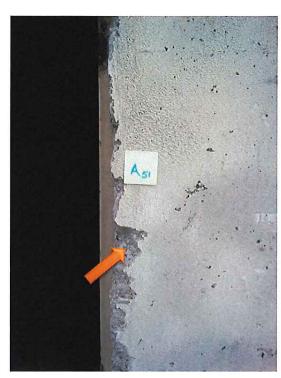
Silo B Exterior Grout Material

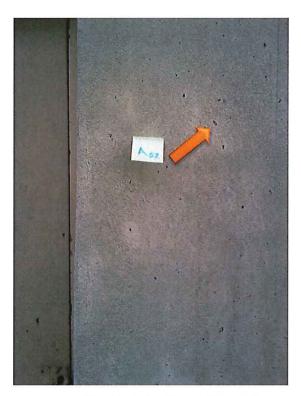
Silo C Exterior Grout Material

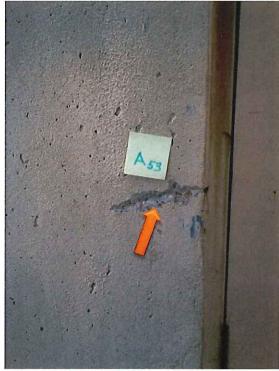
Silo D Exterior Grout Material

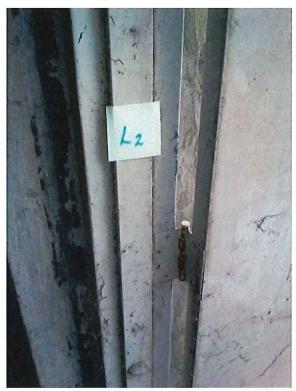
Paint Sample - Door Frame entrance Silo B

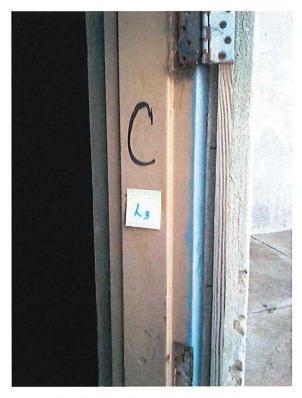
Paint Sample – Door Frame entrance Silo C

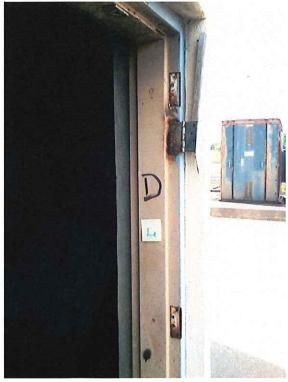
Paint Sample – Door Frame entrance Silo D

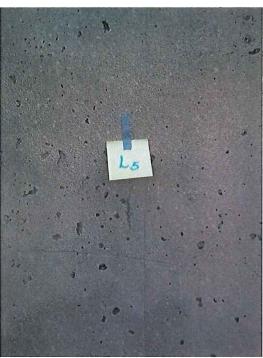
Exterior Paint on surface Silo B

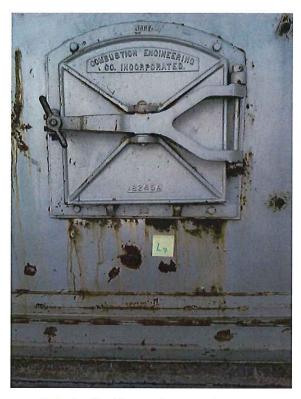
Exterior Coating on Furnace A

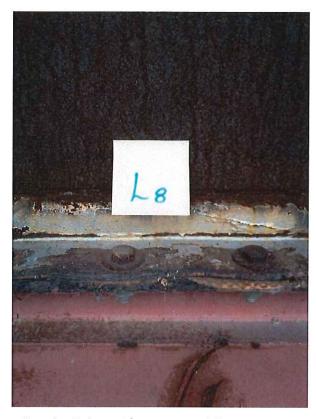
Exterior Paint at Blower Vent Piping Furnace B

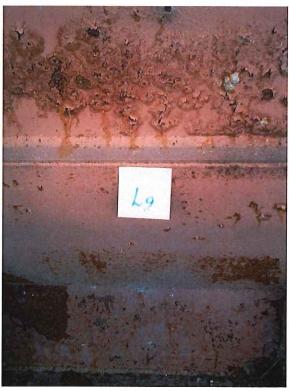
Exterior Paint at Blower Vent Base Furnace B

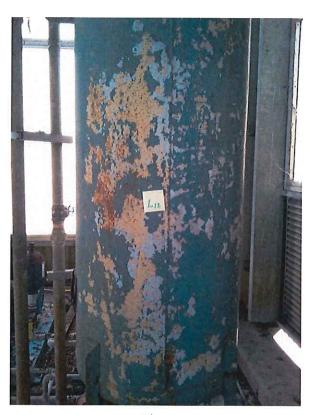
Vertical Chemical Tank 2nd level BPA Furnace Facility

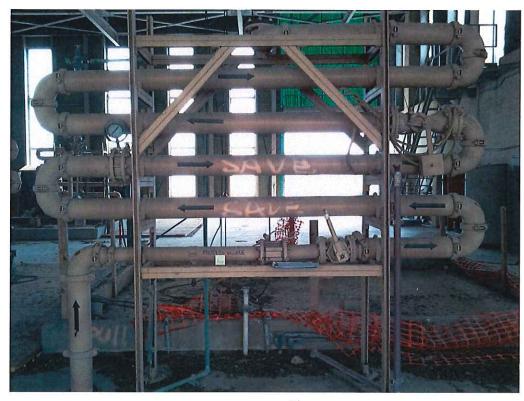
Process Sludge Piping system 2nd level Belt Press area

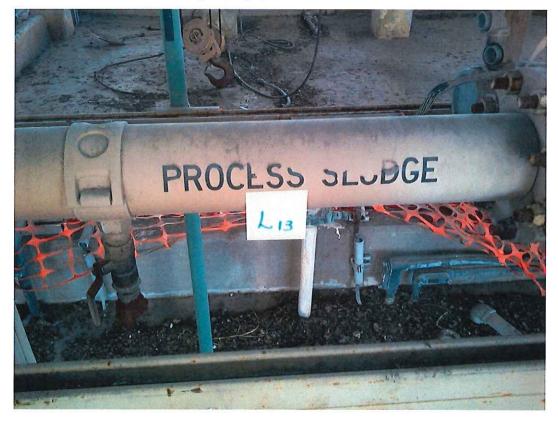
Belt Press Area 3rd Level

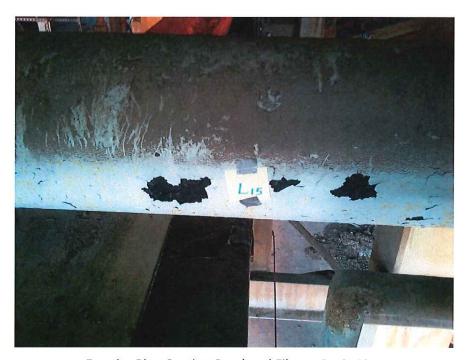
Exterior Pipe Coating Overhead Filtrate Drain Pipe
